3. INSPECTION FINDINGS

Pier 40 is in overall **Poor** condition with 22% of the H-piles rated Major and 35% of the H-piles rated Severe, primarily due to severe corrosion within the splash zone at the top of the H-piles.

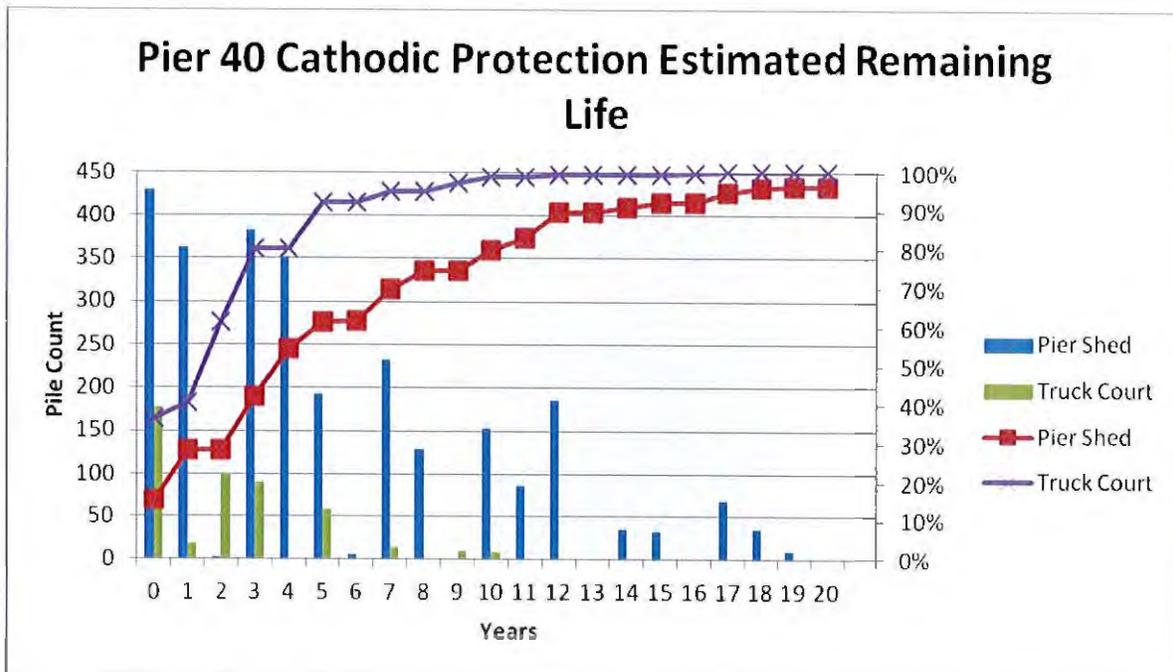
The Court Yard H-piles are typically protected by two anodes per pile. The remaining useful life of these anodes ranges between 0 years and 17 years, with a median remaining useful life of 1 year. The Pier Shed H-piles are protected by two to five anodes per pile. The remaining useful life of these anodes ranges between 0 years and more than 20 years, with a median remaining useful life of 3.5 years. The graph below illustrates the information provided in the table above.

As illustrated in the graph above, a steep increase in the number of unprotected H-piles is expected over the next 3 years under the Court Yard. The Pier Shed is expected to experience a steady increase in unprotected H-piles over the next 10 years.

While it is estimated that the majority of the pier is protected at the time of this report, most of the sacrificial cathodic protection system appears to be at the end of its useful life. Considering the items presented in the list above, and the degenerative effects of saltwater on an uncoated steel structure, it is recommended that action be taken to protect the steel H-piles supporting Pier 40. It is important to note that the data presented does not reflect the entire pier structure and that the items listed above introduce additional uncertainties regarding the overall protection of the pier.
